REPORT NO: SY-139R-77  
AIRTASK NO: A5345341/0532/7534000001  
WORK UNIT NO: A53411-20  
DATE: 13 July 1977

COPY NO. 45 **NAVAL AIR TEST CENTER**  
**REPORT OF TEST RESULTS**

Test and Evaluation of AH-1T Forward Ground Handling Gear Assembly (P/N 209-052-244-1);  
Second Report (Final)

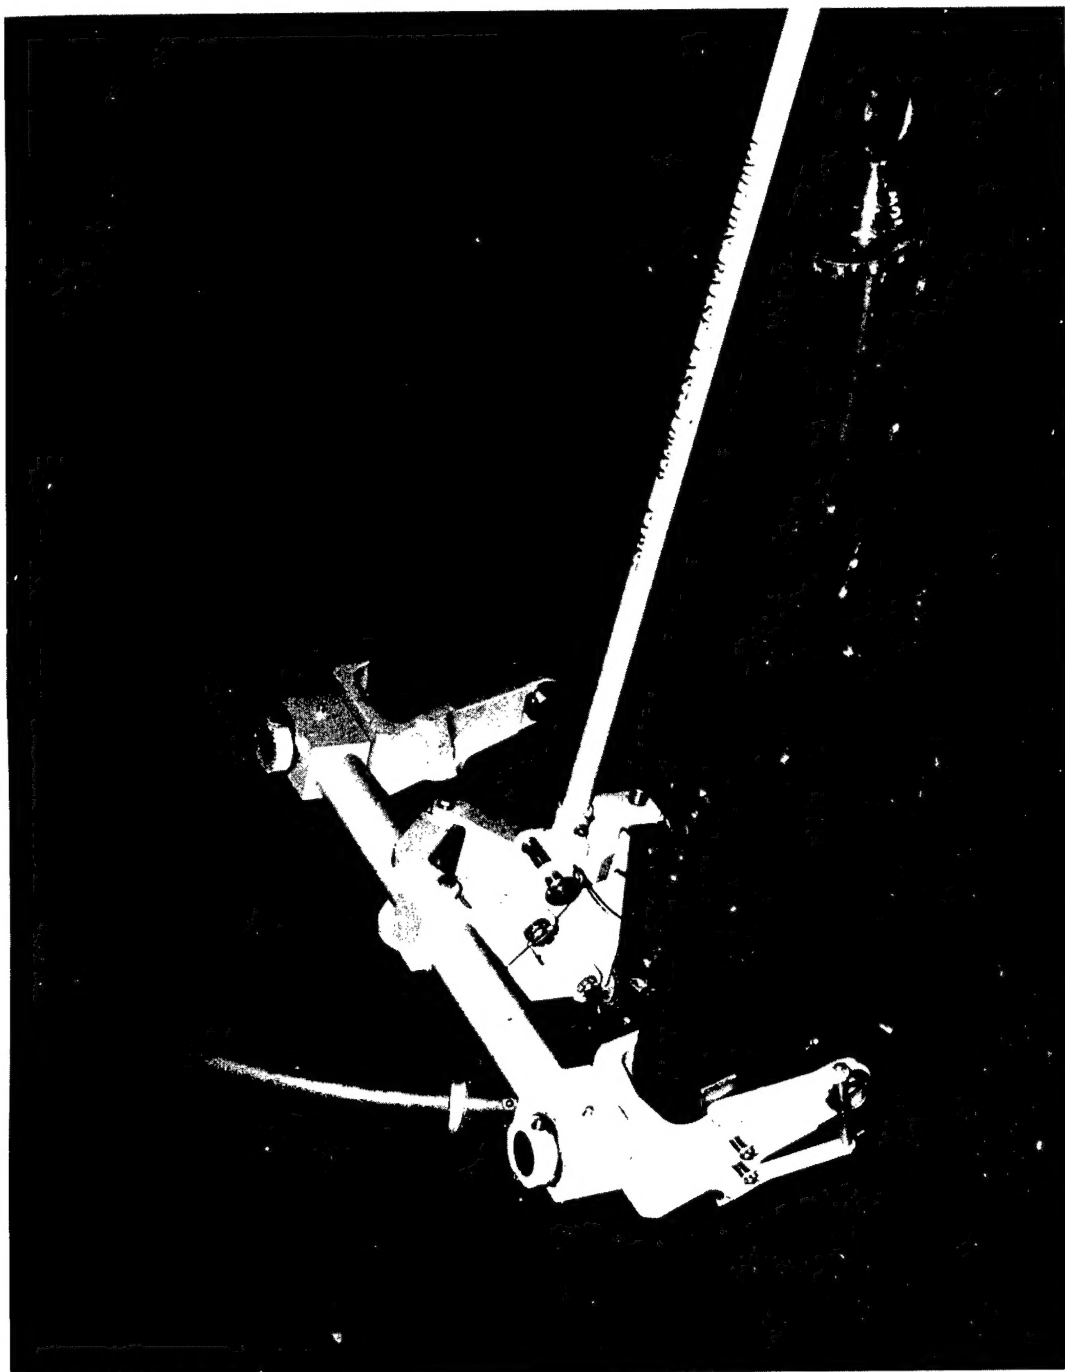
3. The Forward Ground Handling Gear Assembly (enclosure (1), figure 1) consists of two full castoring wheels connected by a common trunnion with a lift mechanism and a 36 in. (91.4 cm) lever handle. The Gear Assembly is attached to two lugs on the forward portion of each skid by means of a solid pin which engages the rear lug and a quick release pin that engages the front lug in the aircraft skid. The lever handle must be held straight up in a vertical position while installing the Gear Assembly, then rotated forward and down to the horizontal position to raise the front portion of the aircraft skid.

Figure 1  
Forward Ground Handling Gear Assembly (P/N 209-052-244-1)

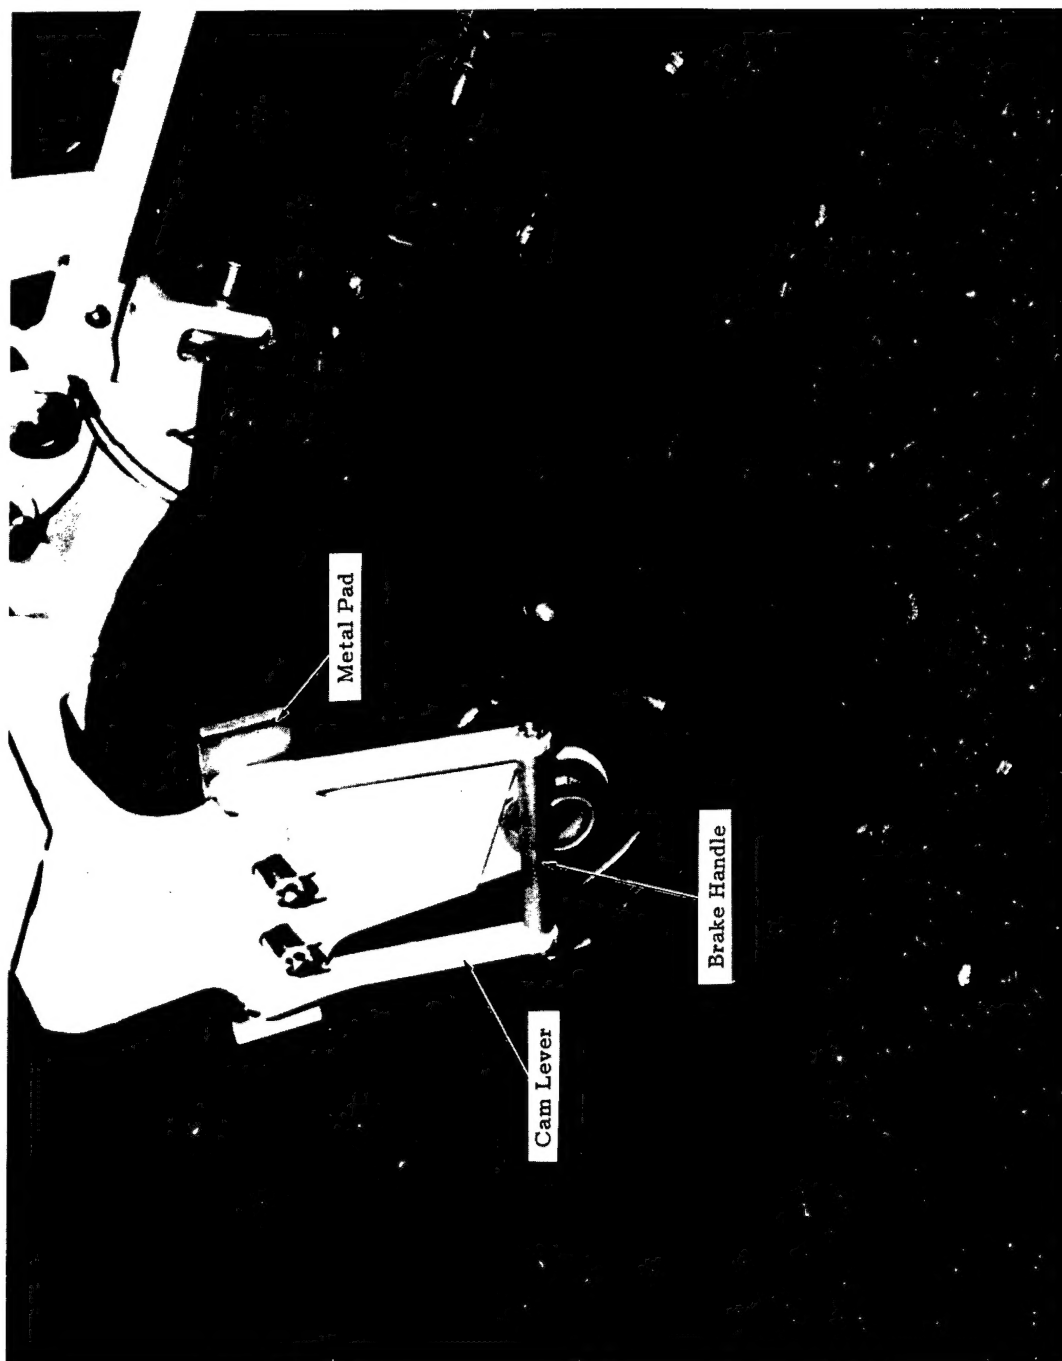
5. The means of stopping tire rotation are inadequate. The brake assembly consists of a cam-lever that contacts a metal pad which then presses against only one side of the pneumatic tire (enclosure (1), figure 2). Applying pressure to only one side of the tire causes tire deflection but does not prevent tire rotation. In addition, there is only one brake on each Gear Assembly which is located on the side of a caster housing. When the aircraft is being moved in one direction, the brake assembly is outboard of the tire. However, when the direction is reversed, the castored wheel rotates 180 deg placing the brake assembly on the inboard side of the tire. This type of brake assembly will result in maintenance personnel not being able to stop the aircraft in an emergency situation. The inadequate means of stopping tire rotation is a Part I deficiency which must be corrected as soon as possible.

14. Inadequate means of stopping tire rotation (paragraph 5).

Figure 2  
Brake Assembly

21. Correct the Part I deficiencies cited in paragraphs 13 through 16 as soon as possible.

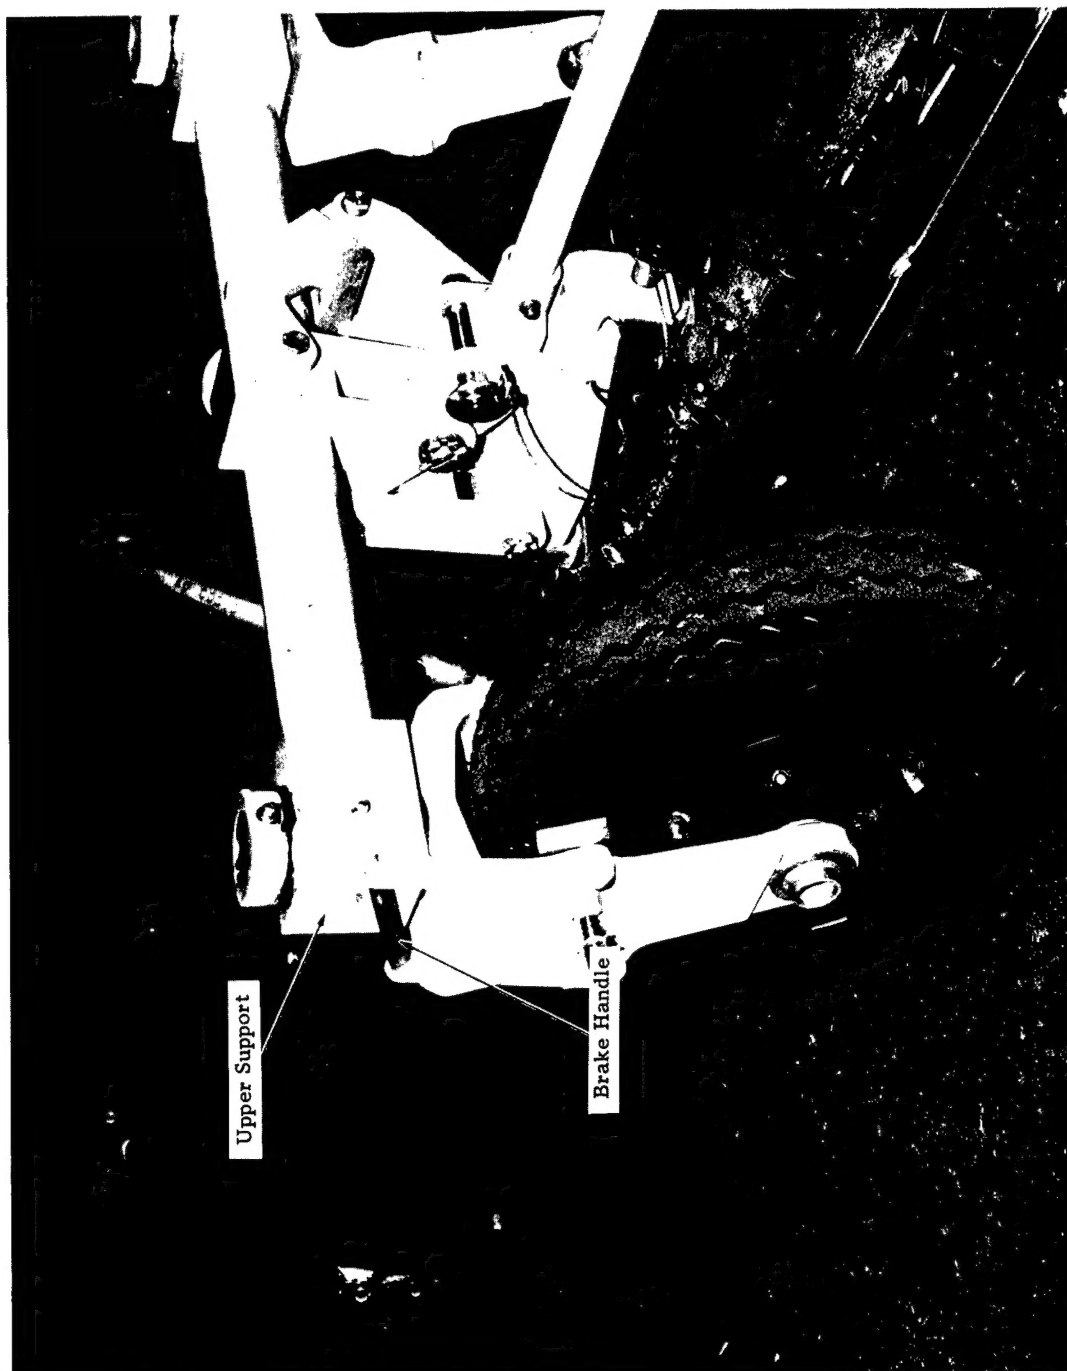
6. There is a lack of provisions to prevent the brake assembly handle from being rotated 180 deg through the horizontal position. While the brake is off, the handle is in a vertical down position (enclosure (1), figure 2). To engage the brake, the handle must be pulled up to a horizontal position. Continuing to pull the handle up over center will place it in a vertical up position and will disengage the brake. In the up position, the handle will rest against the upper support of the wheel assembly (enclosure (1) figure 3). Maintenance personnel applying the brake and

failing to stop at the horizontal position will have their hand trapped between the brake handle and upper support of the Gear Assembly. Failure to provide a stop that will prevent the handle from being rotated through the horizontal position will result in a potential safety hazard to maintenance personnel. The lack of provisions to prevent the brake assembly handle from being rotated 180 deg through the horizontal position is a Part I deficiency which must be corrected as soon as possible.

15. Lack of provisions to prevent the brake assembly handle from being rotated 180 deg through the horizontal position (paragraph 6).

Figure 3  
Interference Between Brake Handle and Upper Support

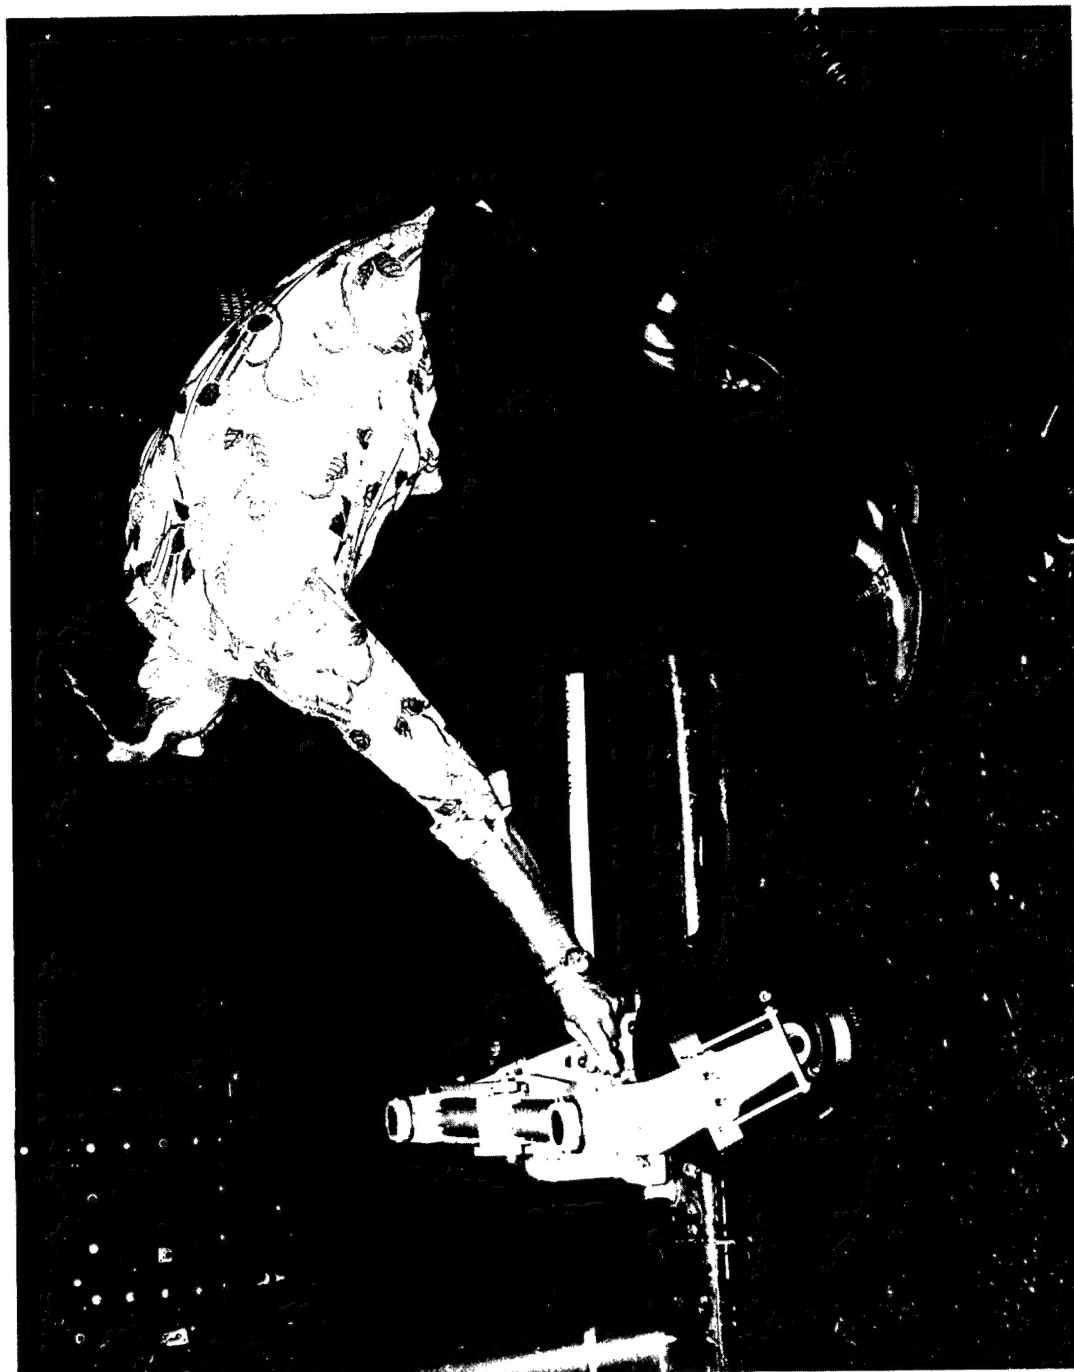
9. The length of the wire rope assemblies that secure the two quick release pins to the Gear Assembly is excessive. One quick release pin is used for securing the Gear Assembly to the aircraft skid front lug and the other quick release pin is used for securing the lever handle in the down position (enclosure (1), figure 6). These pins are different lengths and if interchanged will not function satisfactorily. The length of the wire rope assemblies allow either pin to be used for either application which results in a "MURPHY" situation. Also, the quick release pin could be damaged as a result of being caught under the skid while lowering the aircraft. The excessive length of the wire rope assemblies constitutes a Part II deficiency which should be corrected as soon as practicable.

18. Excessive length of quick release pin wire rope assemblies (paragraph 9).

Figure 5  
Inserting Quick Release Pin in Gear Assembly Housing

22. Correct the Part II deficiencies cited in paragraphs 17 through 19 as soon as practicable.

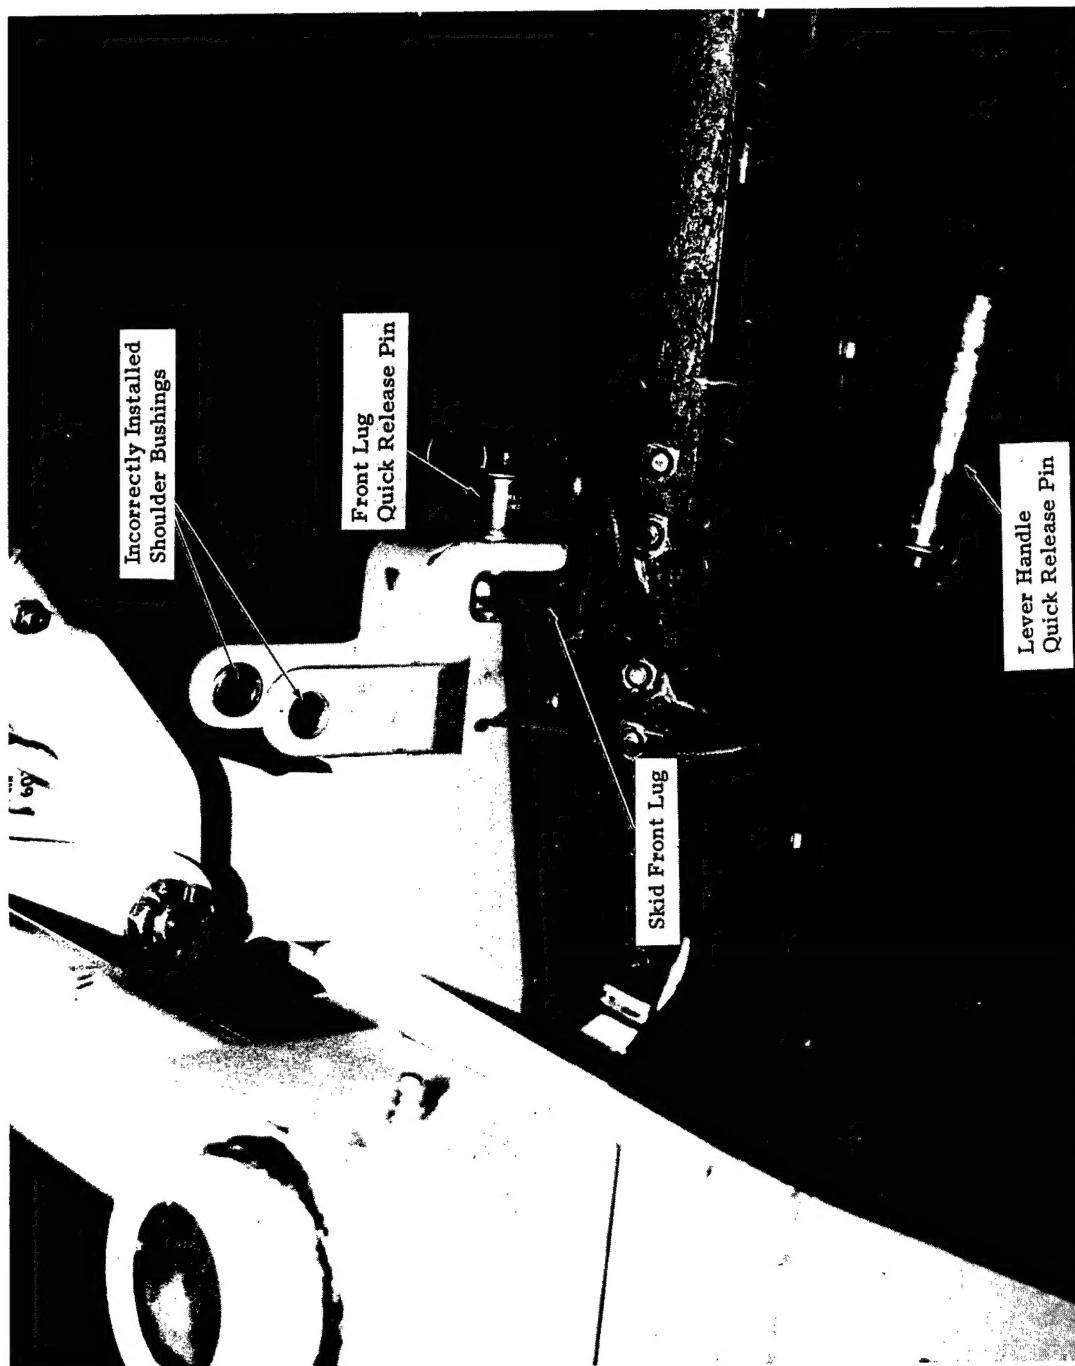
10. There is a lack of support for both ends of quick release pin. The forward attachment point for securing the Gear Assembly to the aircraft skid (enclosure (1), figure 6) consists of a bushed hole in the gear housing. A quick release pin is inserted through the bushed hole and a hole in the aircraft skid front lug. The aircraft weight is exerted on the quick release pin which is not supported at both ends and results in a bending moment being applied to the quick release pin. Failure to support the quick release pin at both ends so that a shear load is applied to the pin will cause excessive bushing wear and pin deformation which will result in the inability to secure the wheel assembly to the aircraft. The lack of support for both ends of the quick release pin is a Part II deficiency which should be corrected as soon as practicable.

19. Lack of support for both ends of the forward attachment point quick release pin (paragraph 10).

Figure 6  
Quick Release Pin Housing
